**Flood Control Project Maintenance  
Levee Inspections**

**Maintenance Issue Types Only, Levee Inspection Report By Mile - Fall 2016**

**Reclamation District No. 1601 Twitchell**

Waterway	Bank	Unit Miles	Inspection Start/End	Inspector
Unit No. 01 Threemile Slough	Left	2.43	09/08/2016 09/08/2016	Richard Willoughby

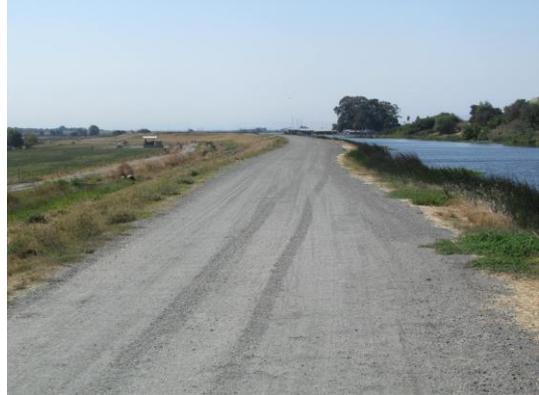
Photo 1 of 1 : FA\_2016\_RD1601\_237\_13\_20160909\_00019.jpg

LM Start	<b>0.00</b>	Rating **	A	Issue No.	<b>13</b>
LM End	<b>0.25</b>	Issue Type +	Ma	Location *	CR
Category	Earthen Levee			GPS Latitude/Longitude	
				Start	End
Item	Crown Surface / Depressions / Rutting			38.122235°	°
				-121.682553°	°
DWR ID	DWR_RD1601_01_s_2015_13				
Comment Code					
C2 : Repair depressions or ruts in the crown or slope.					
Inspector Comment					
Acceptable levee crown.

Looking south at overview of levee. Fall 2016.

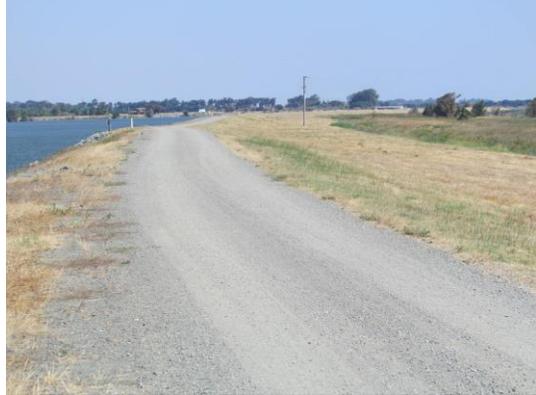
Photo 1 of 1 : FA\_2016\_RD1601\_237\_2\_20160909\_00020.jpg

LM Start	<b>1.00</b>	Rating **	A	Issue No.	<b>2</b>
LM End	<b>1.07</b>	Issue Type +	Ma	Location *	CR
Category	Earthen Levee			GPS Latitude/Longitude	
				Start	End
Item	Crown Surface / Depressions / Rutting			38.108088°	38.107128°
				-121.682784°	-121.683190°
DWR ID	DWR_RD1601_01_f_2015_2				
Comment Code					
C2 : Repair depressions or ruts in the crown or slope.					
Inspector Comment

Looking northwest at overview of levee.
